Etat quantitatif des captages utilisés pour l'eau potable

Situation des points de prélèvement AEP au 15 mars 2022

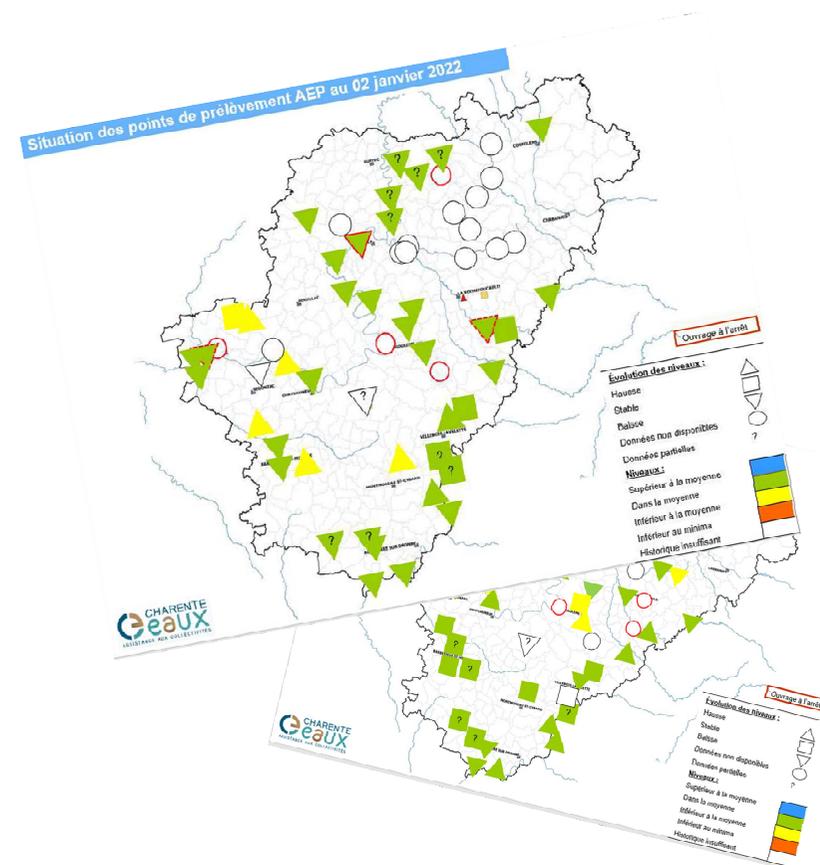
► Les points à retenir depuis janvier 2022 :

Des précipitations significatives :

- 3 épisodes pluvieux ponctuels (1 par mois),
- Une recharge des nappes libres et la poursuite des nappes captives (janvier),
- Une phase de tarissement pendant plus d'un mois (notamment pour les nappes libres),
- Deux épisodes pluvieux depuis le mois de février (non efficaces pour les nappes libres).

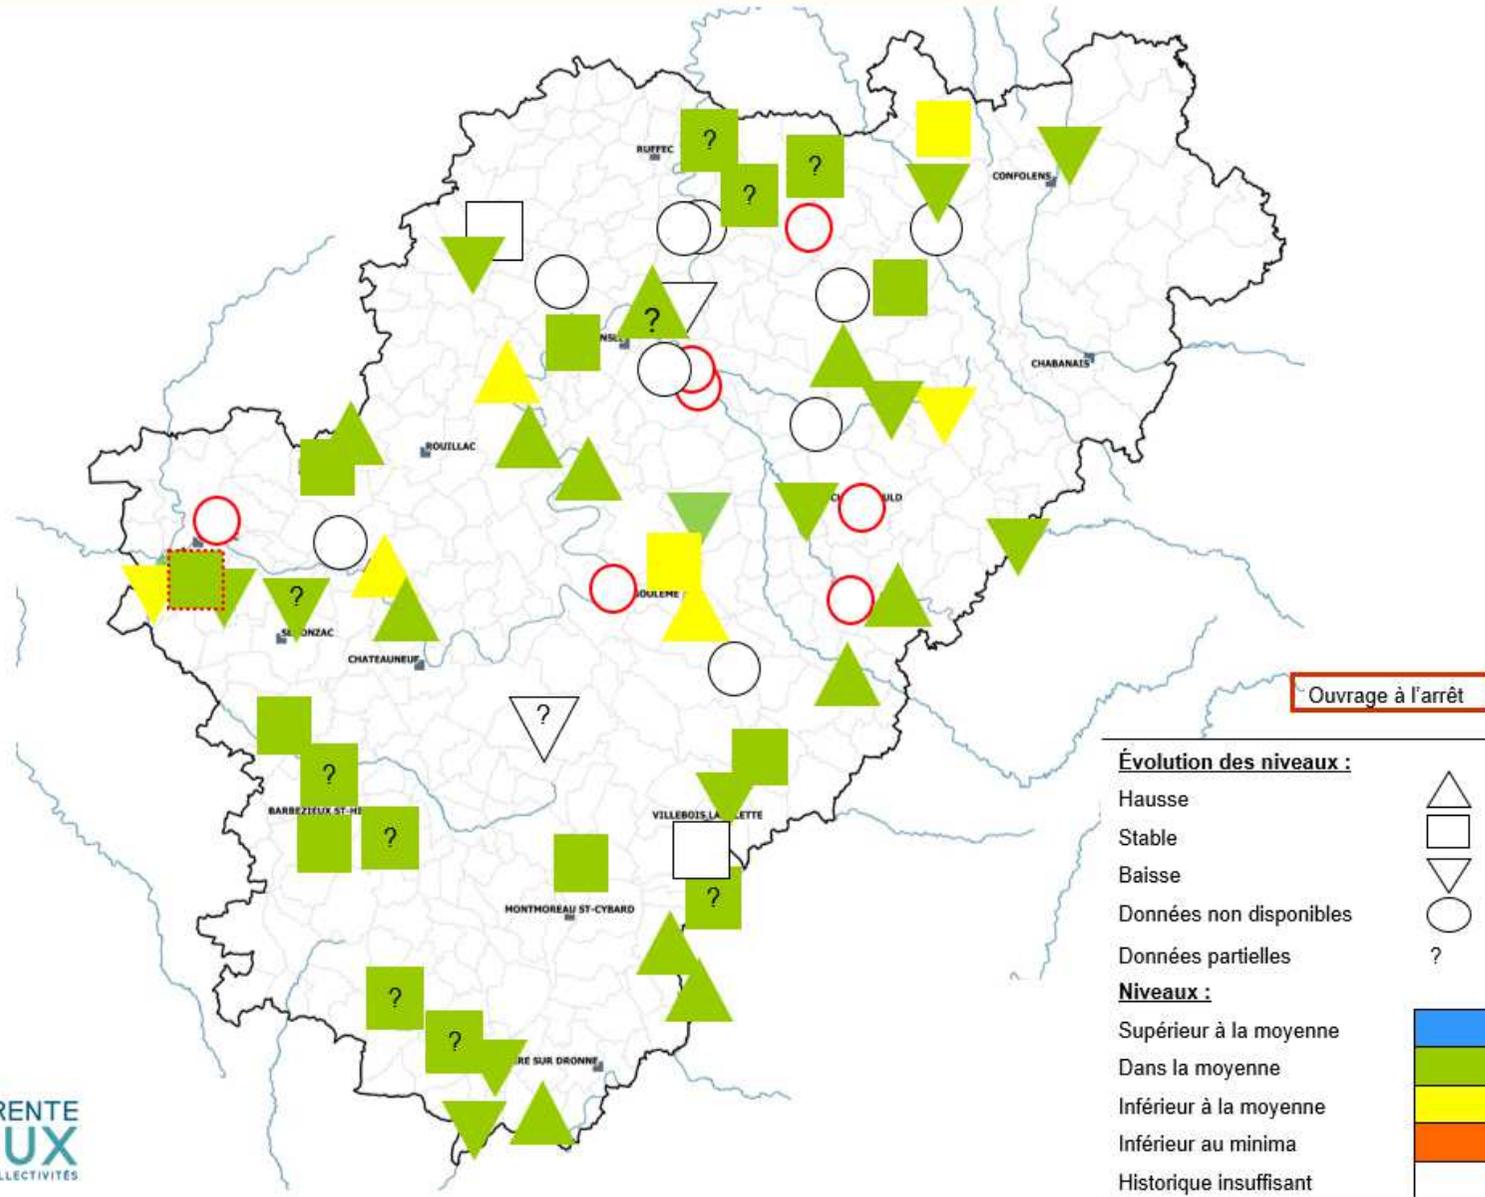
► Bilan de la situation début 2022 :

Début janvier 2022, à l'image de l'état de la ressource superficielle et souterraine, les captages AEP suivent les mêmes tendances :

- du point de vue quantitatif, les précipitations du premier trimestre 2022 ont permis la recharge, sans excédent, de la majorité des nappes captives;
- La recharge des nappes libres n'est pas terminée;
- certains ouvrages sont à l'arrêt (choix d'exploitation, teneur en turbidité trop élevée, travaux en cours).

La continuité des services est assurée du fait de la sécurisation en place (au sein du service et/ou à l'extérieur).
